Customer Repair Evaluation Report

PD DEAL #: 0000000000 | EVALUATION TECH: | KVA: 3400 | HV: 34500 | LV: 12000Y/6930

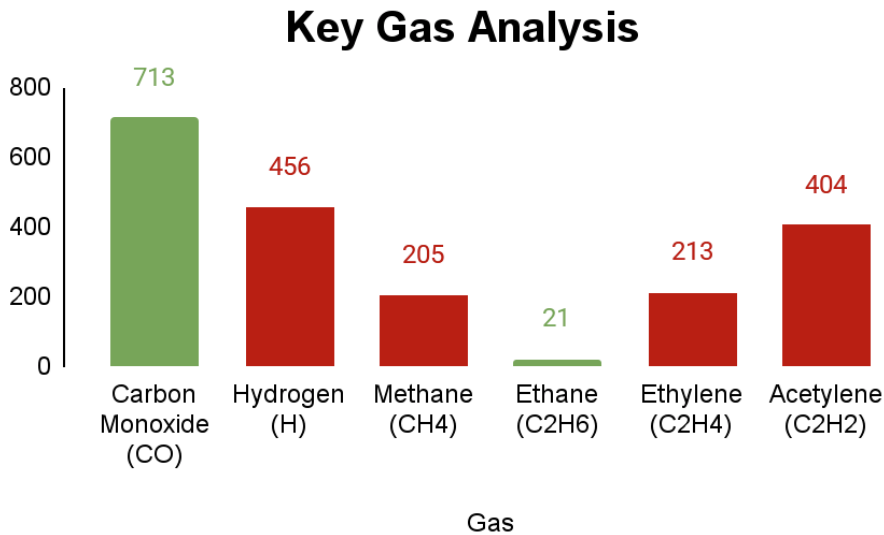
Dissolved Gas Analysis (DGA):

Notes: DGA high in combustible gasses from blown CLF and HV bushing failure

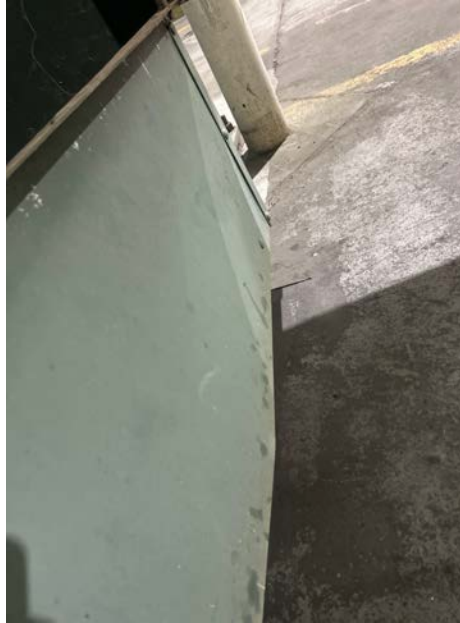
Cabinet/Tank Dents/Bends

Slight kickplate damage in need of straightening.

1. Untank core and coils for further inspection and bakeout
2. Remove components that provide seal surface for fluid and regasket
3. Replace CLF's with **NEW 38kV 165 Amp CLF (HTSS372165)**
4. Replace HV bushings with **six (6) NEW 34.5KV/600amp DB Bushings (Ensuring these are secured correctly internally via lock washer or thinner lock nut)**
5. Replace PRD with **NEW 8lb PRD**
6. Replace Mineral Oil with **New Mineral Oil**
7. Perform Core final test protocol:
 - a. Megger/Insulation winding resistance: H-L, H-G, L-G
 - b. Turns Ratio: All Tap Voltages
 - c. Winding Resistance: All Taps on HV side, LV all phases
 - d. No Load/Excitation Test
 - e. Full Load/ Impedance % Test.
8. Pressure test unit
9. Repaint transformer with ASA 32 Green industrial base oil enamel paint.
10. Perform Core Final QC outgoing documentation process.

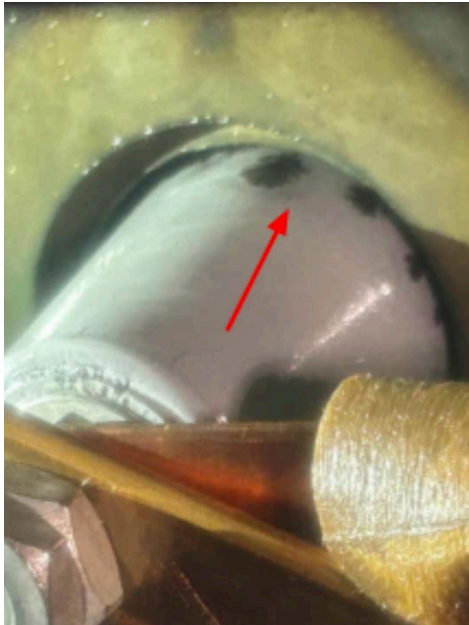
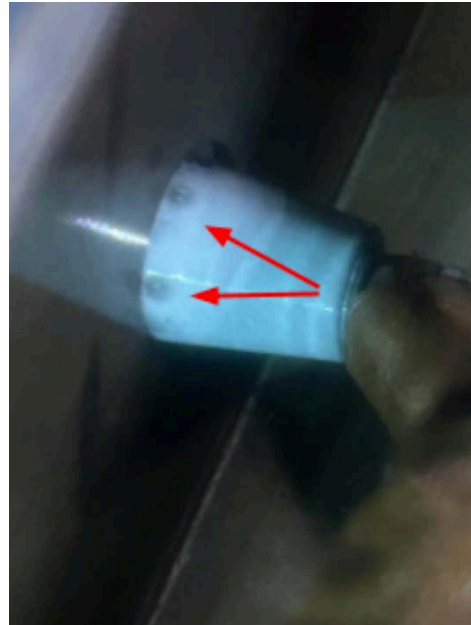
HV Bushing Failure

1. CLF on phase 3 has blown
2. HV Bushings show carbon patterns internally that are synonymous with electrical arcing. These older style 34.5kV/600 amp bushings do not contain an internal ground screen, leading to the patterns you see in the pictures below.
3. Double nut on HV side is not the best secure connection because of the thickness of the tabs on the core leads. There should be a lock washer or thinner nut so it is completely secured on the threads.
4. Kickplate damage in need of straightening

Here you can see where the creep/arcing issue occurred because of the lack of ground screen.

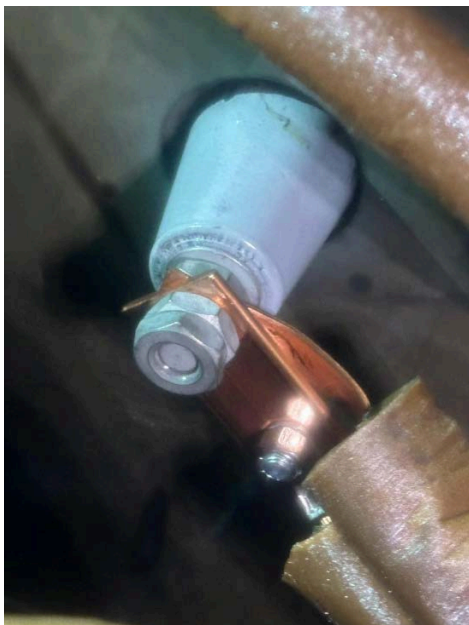
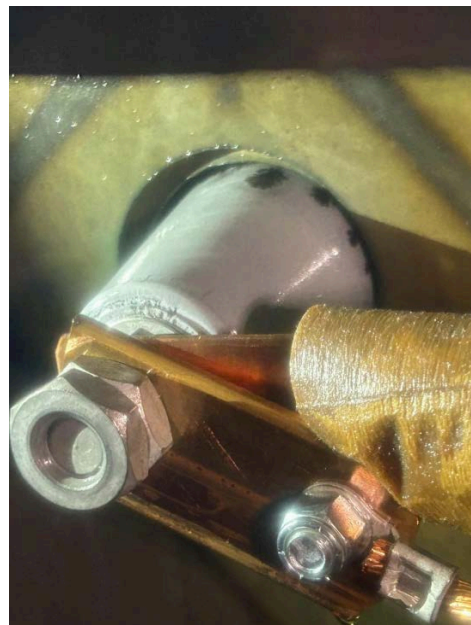
High Side Connection

The lock nut on this connection is just starting its thread on the stud - not a secure and locking connection.
